CASE STUDY: JAMES M. HANLEY FEDERAL BUILDING Building Envelope Investigations

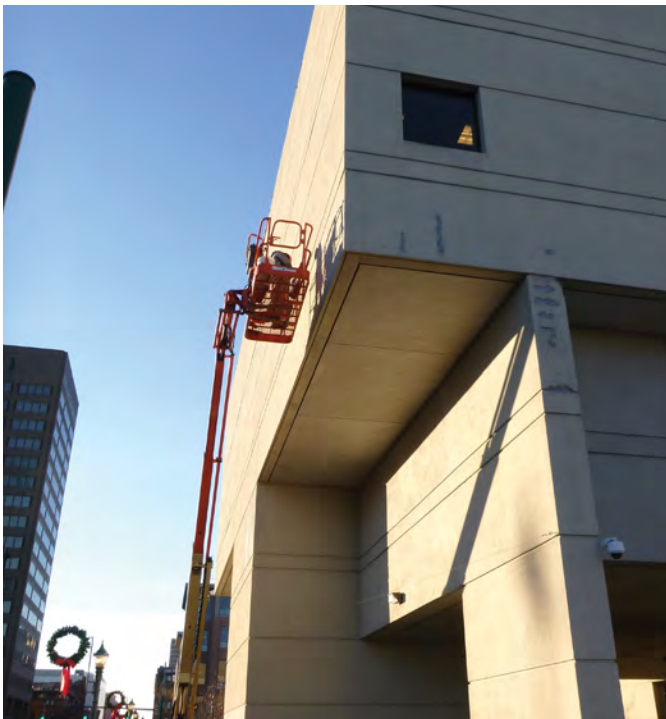
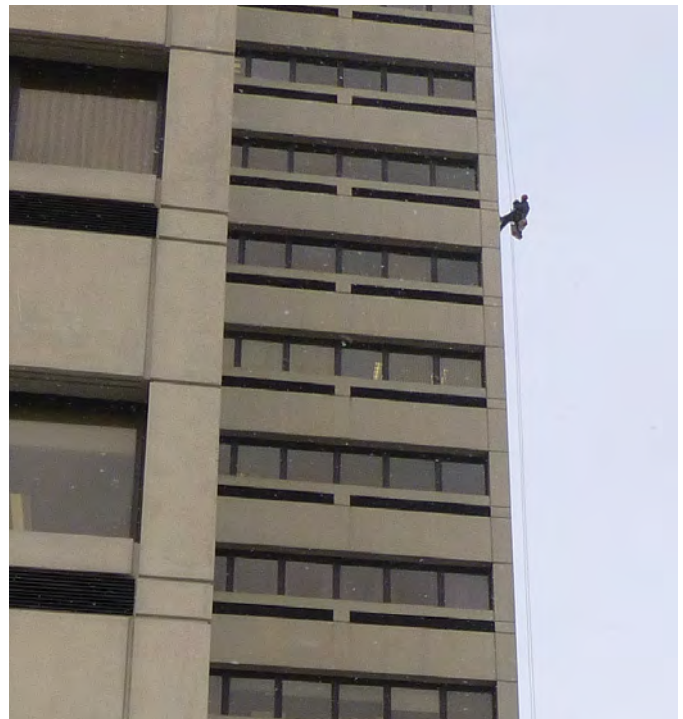
In September 2012, a piece of concrete detached from the façade of the James M. Hanley Federal Building in Syracuse, NY and fell to the ground, after which fences were installed around the perimeter of the building and sidewalk bridges erected at the east and west entrances for public safety.

In September 2012, a piece of concrete detached from the façade of the James M. Hanley Federal Building in Syracuse, NY and fell to the ground. A hands-on periodic inspection program would likely have identified the spalled and loose concrete on the façade before it fell.

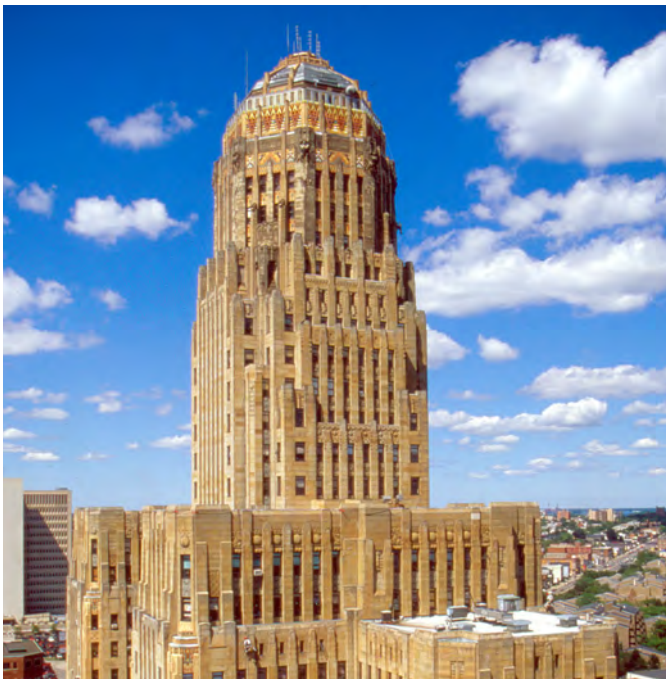
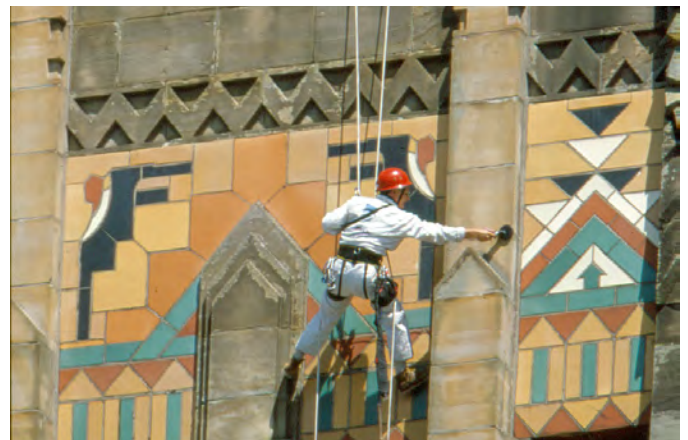
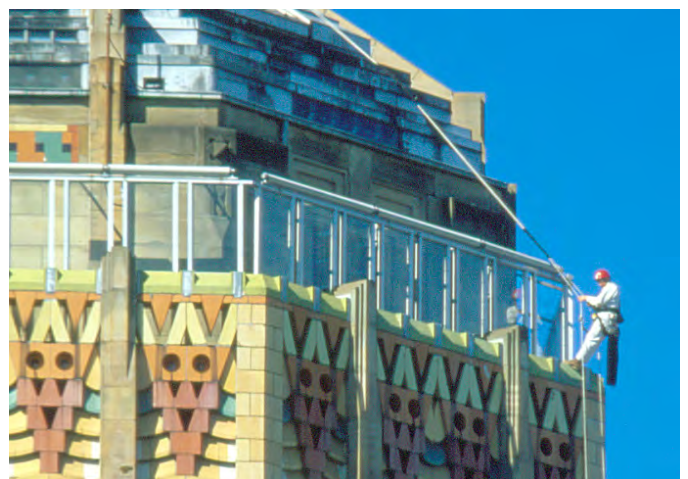
Industrial rope access techniques were used to allow technicians a hands-on inspection of the exterior. The primary focus of the investigation process was to document locations of displaced, cracked and spalled units and failing and open mortar joints in the masonry where repairs are required. Faults were documented on elevation drawings using a typology

Between 2002 and 2009, the City of Buffalo, NY undertook a phased exterior masonry rehabilitation project of the monumental City Hall. The first step of the rehabilitation project was to perform a detailed conditions survey to locate, quantify and evaluate the conditions of deterioration.

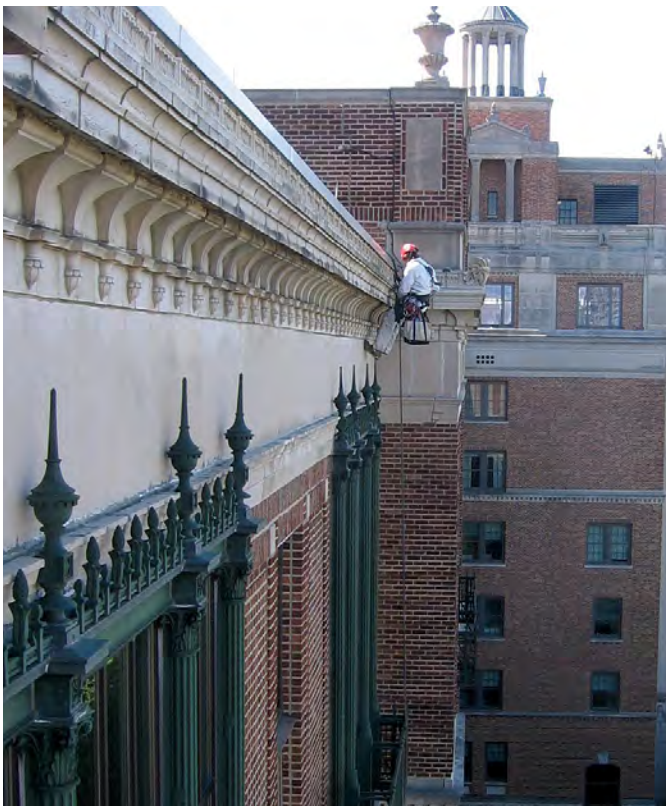
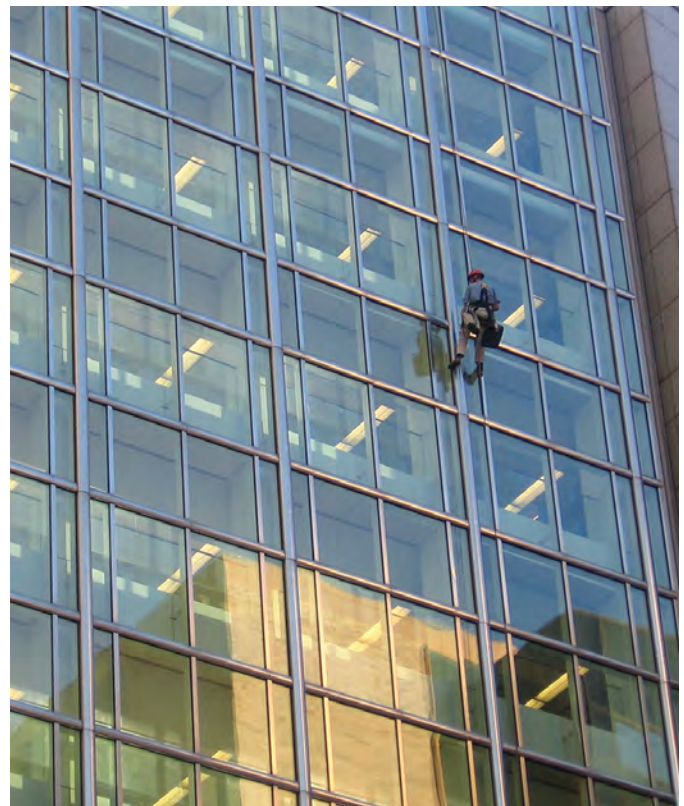
Periodic inspections of four buildings at the Mayo Clinic were performed over several years to help prioritize and plan maintenance and capital repair projects. (Left: Joseph Building in the front and the Francis Building behind. Right: Gonda Building Skyway)
