# Saving the Basilica

CREATIVE ACCESS SOLUTIONS FOR  
INSPECTION AND CONTRACTING  
WORK AT HEIGHT

BY KRISTEN OLSON AND  
KELLY STREETER, PE

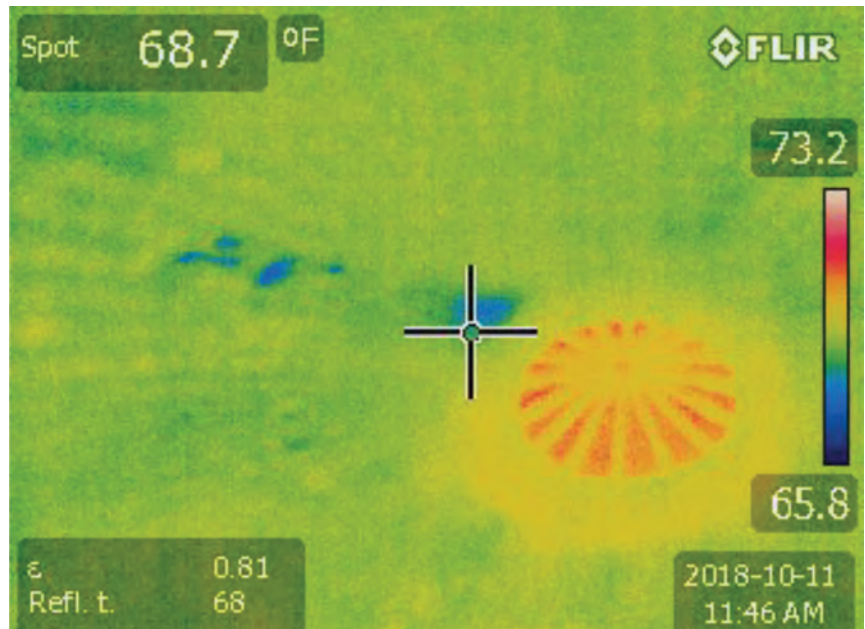
**“Although the elliptical main dome appears to be in overall good condition, VA identified moisture within the tile masonry based on the infrared imagery.”**

**Infrared image of the dome interior. Areas of likely water infiltration appear as a cooler area in blue; the skylight appears in orange.**

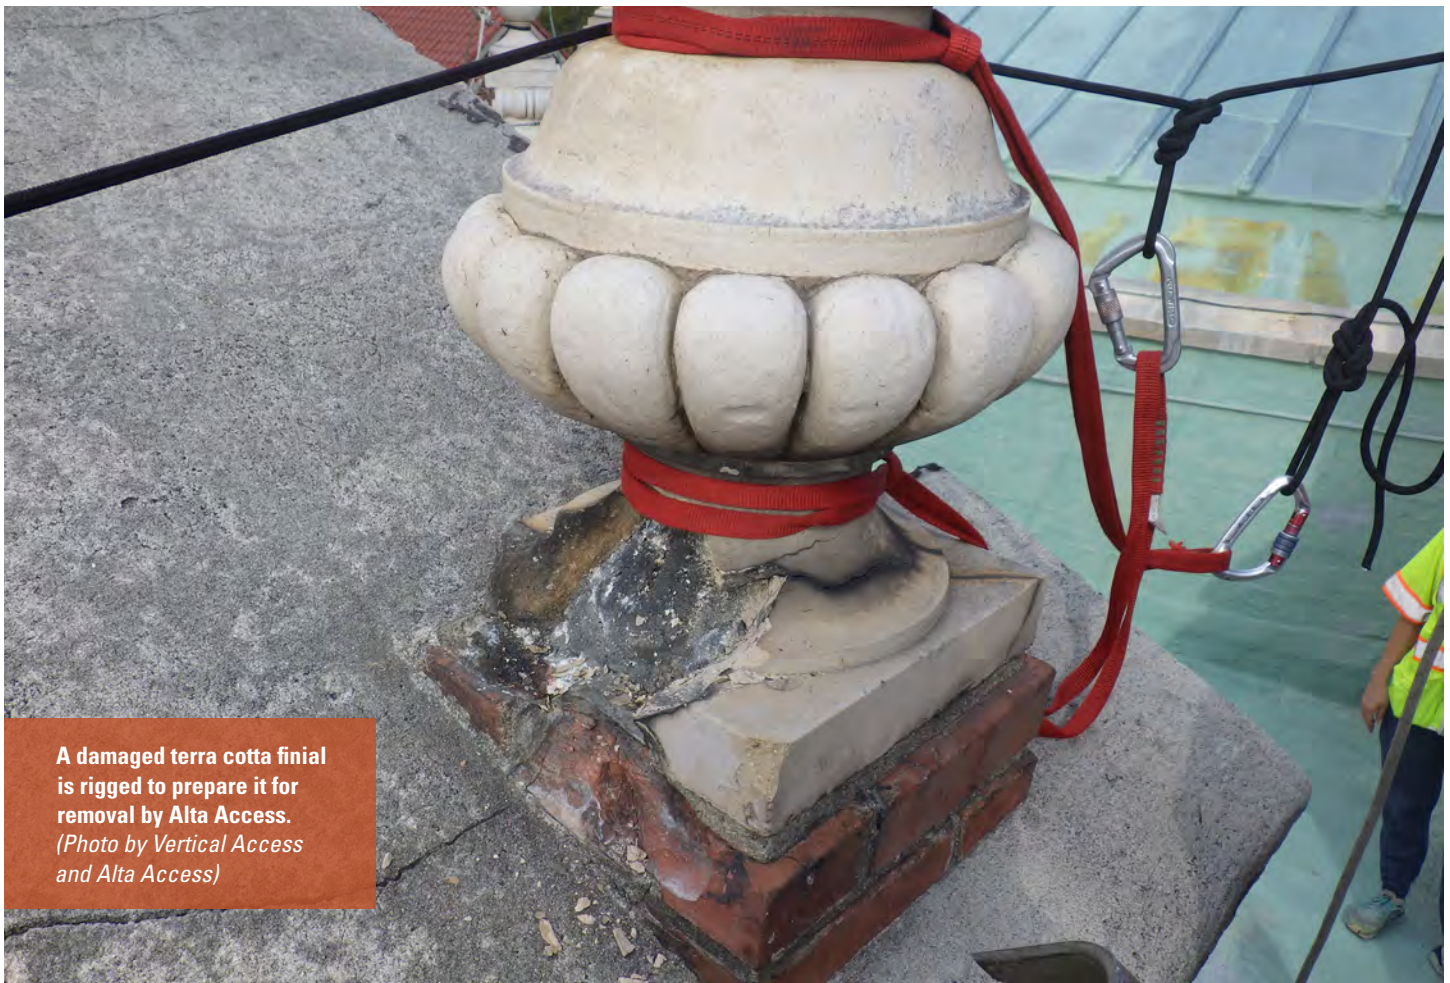
**A damaged terra cotta finial is rigged to prepare it for removal by Alta Access.**  
(Photo by Vertical Access and Alta Access)

Alta technicians removed damaged portions of three terra cotta finials. Discrete areas of loose brick masonry were removed by hand at the towers and east façade, while larger areas of deteriorating and unstable masonry were mitigated by the installation of debris containment netting. Three netting samples were installed in easy-to-access locations representing a variety of exposures, while a fourth control sample was left with the building manager for future evaluation of the netting performance in different weathering conditions.

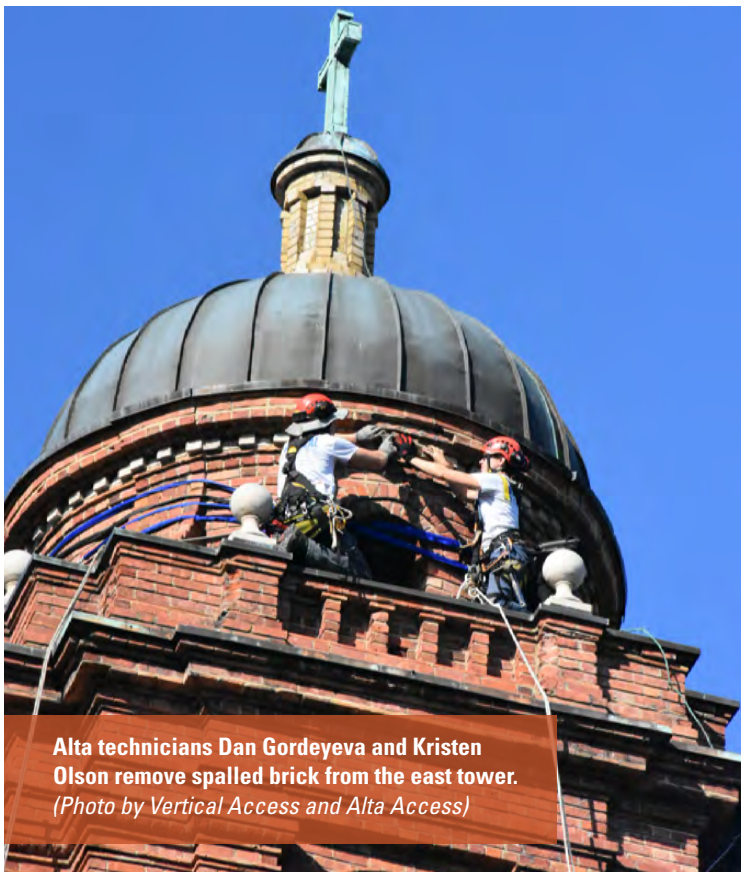
**Alta technicians Dan Gordeyeva and Kristen Olson remove spalled brick from the east tower.**  
(Photo by Vertical Access and Alta Access)

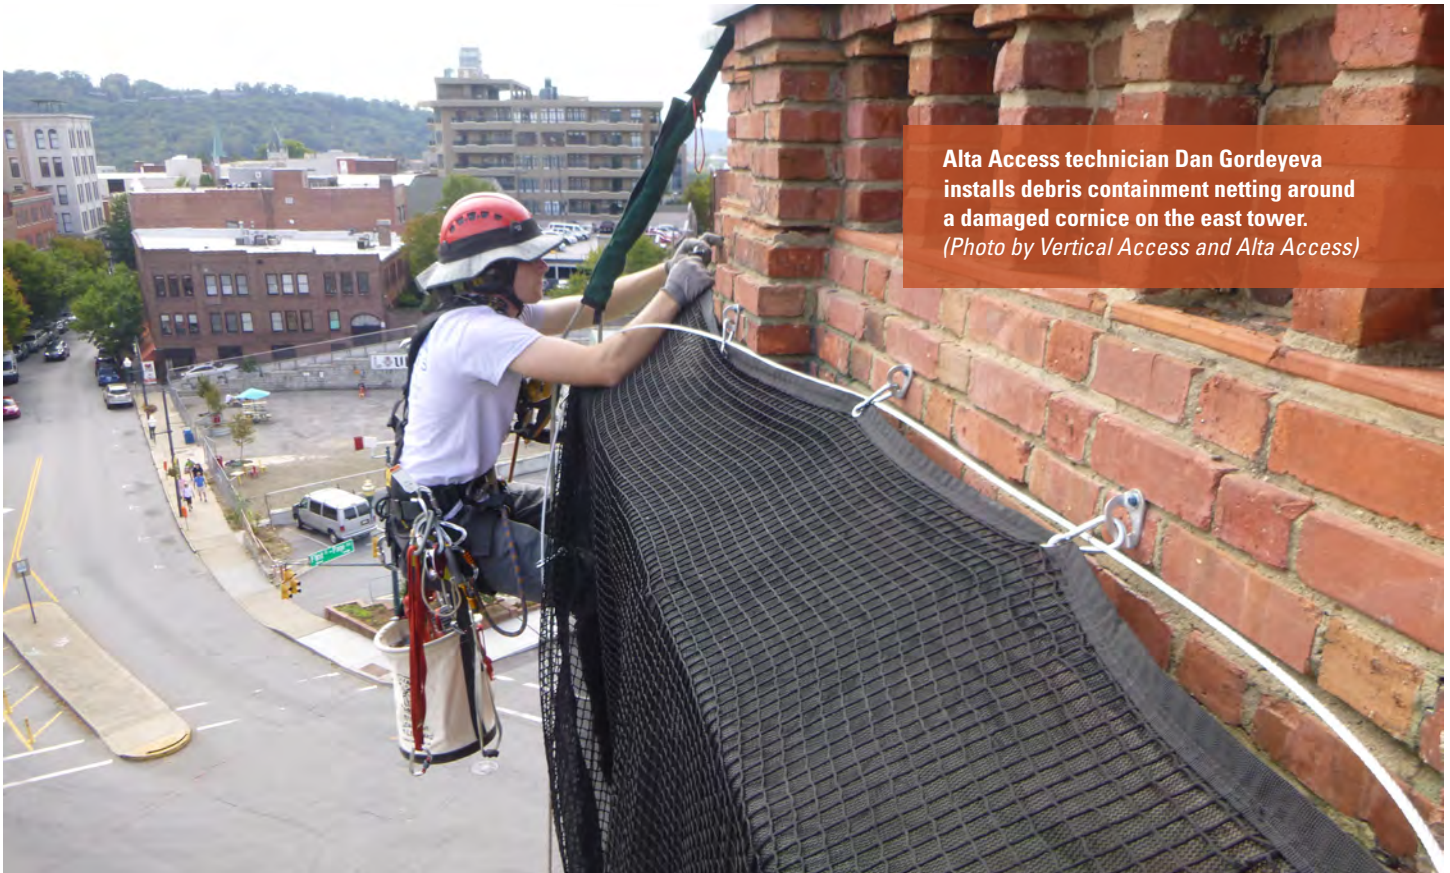
**Alta Access technician Dan Gordeyeva** installs debris containment netting around a damaged cornice on the east tower.  
*(Photo by Vertical Access and Alta Access)*

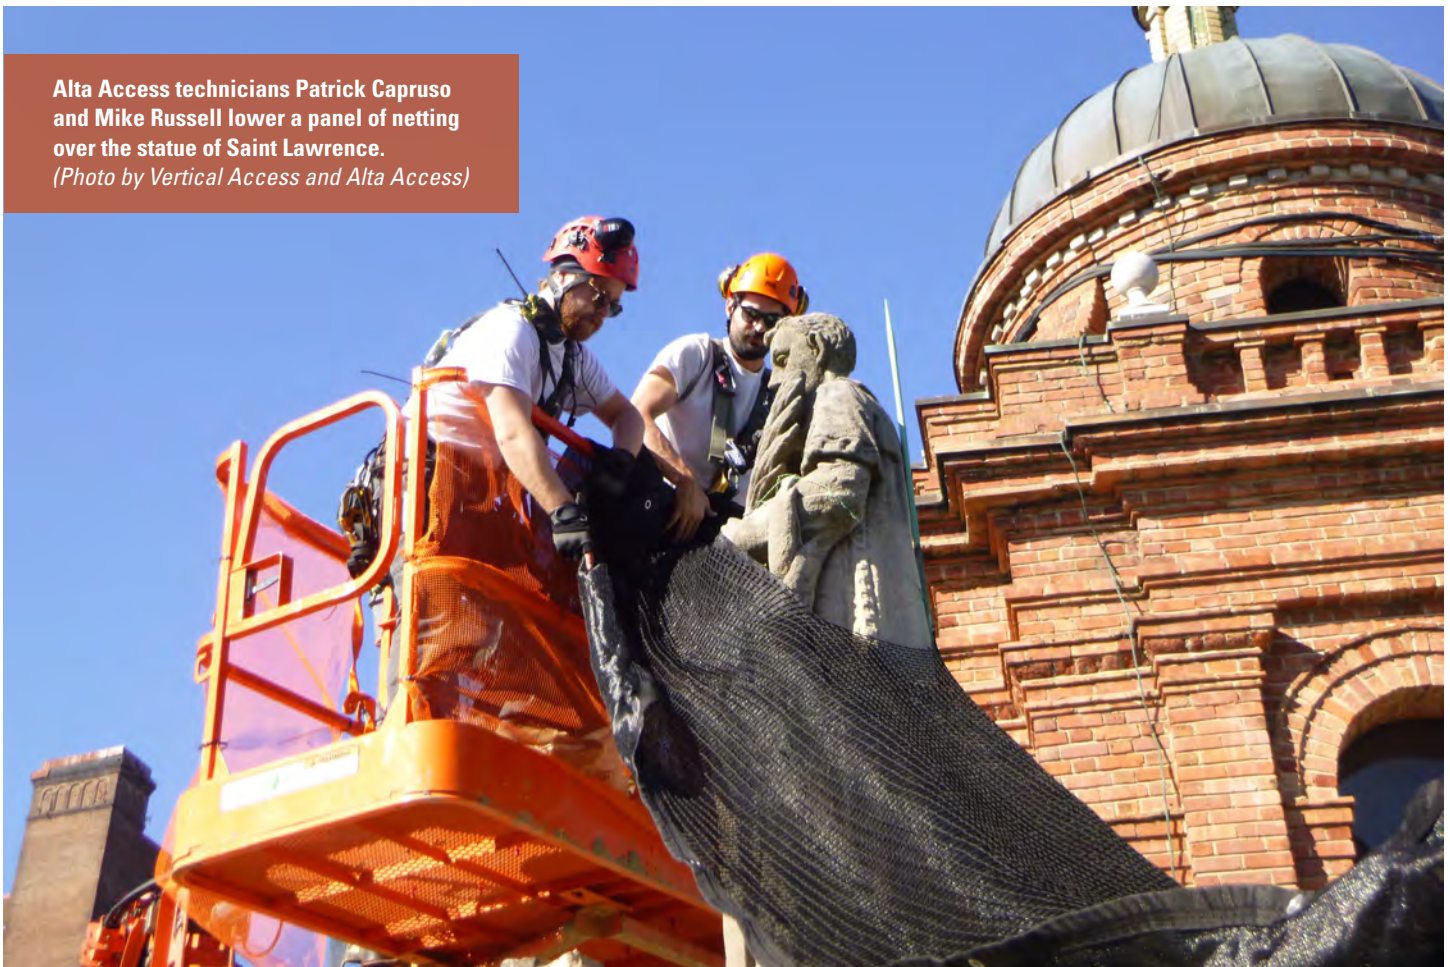
**Alta Access technicians Patrick Capruso** and **Mike Russell** lower a panel of netting over the statue of Saint Lawrence.  
*(Photo by Vertical Access and Alta Access)*

One of the most critical areas was the pediment over the main entrance to the church, which required field cutting the net to fit over the statue of St. Lawrence. Cracks at the skyward-facing surfaces of the pediment were repaired with mortar prior to the netting installation.

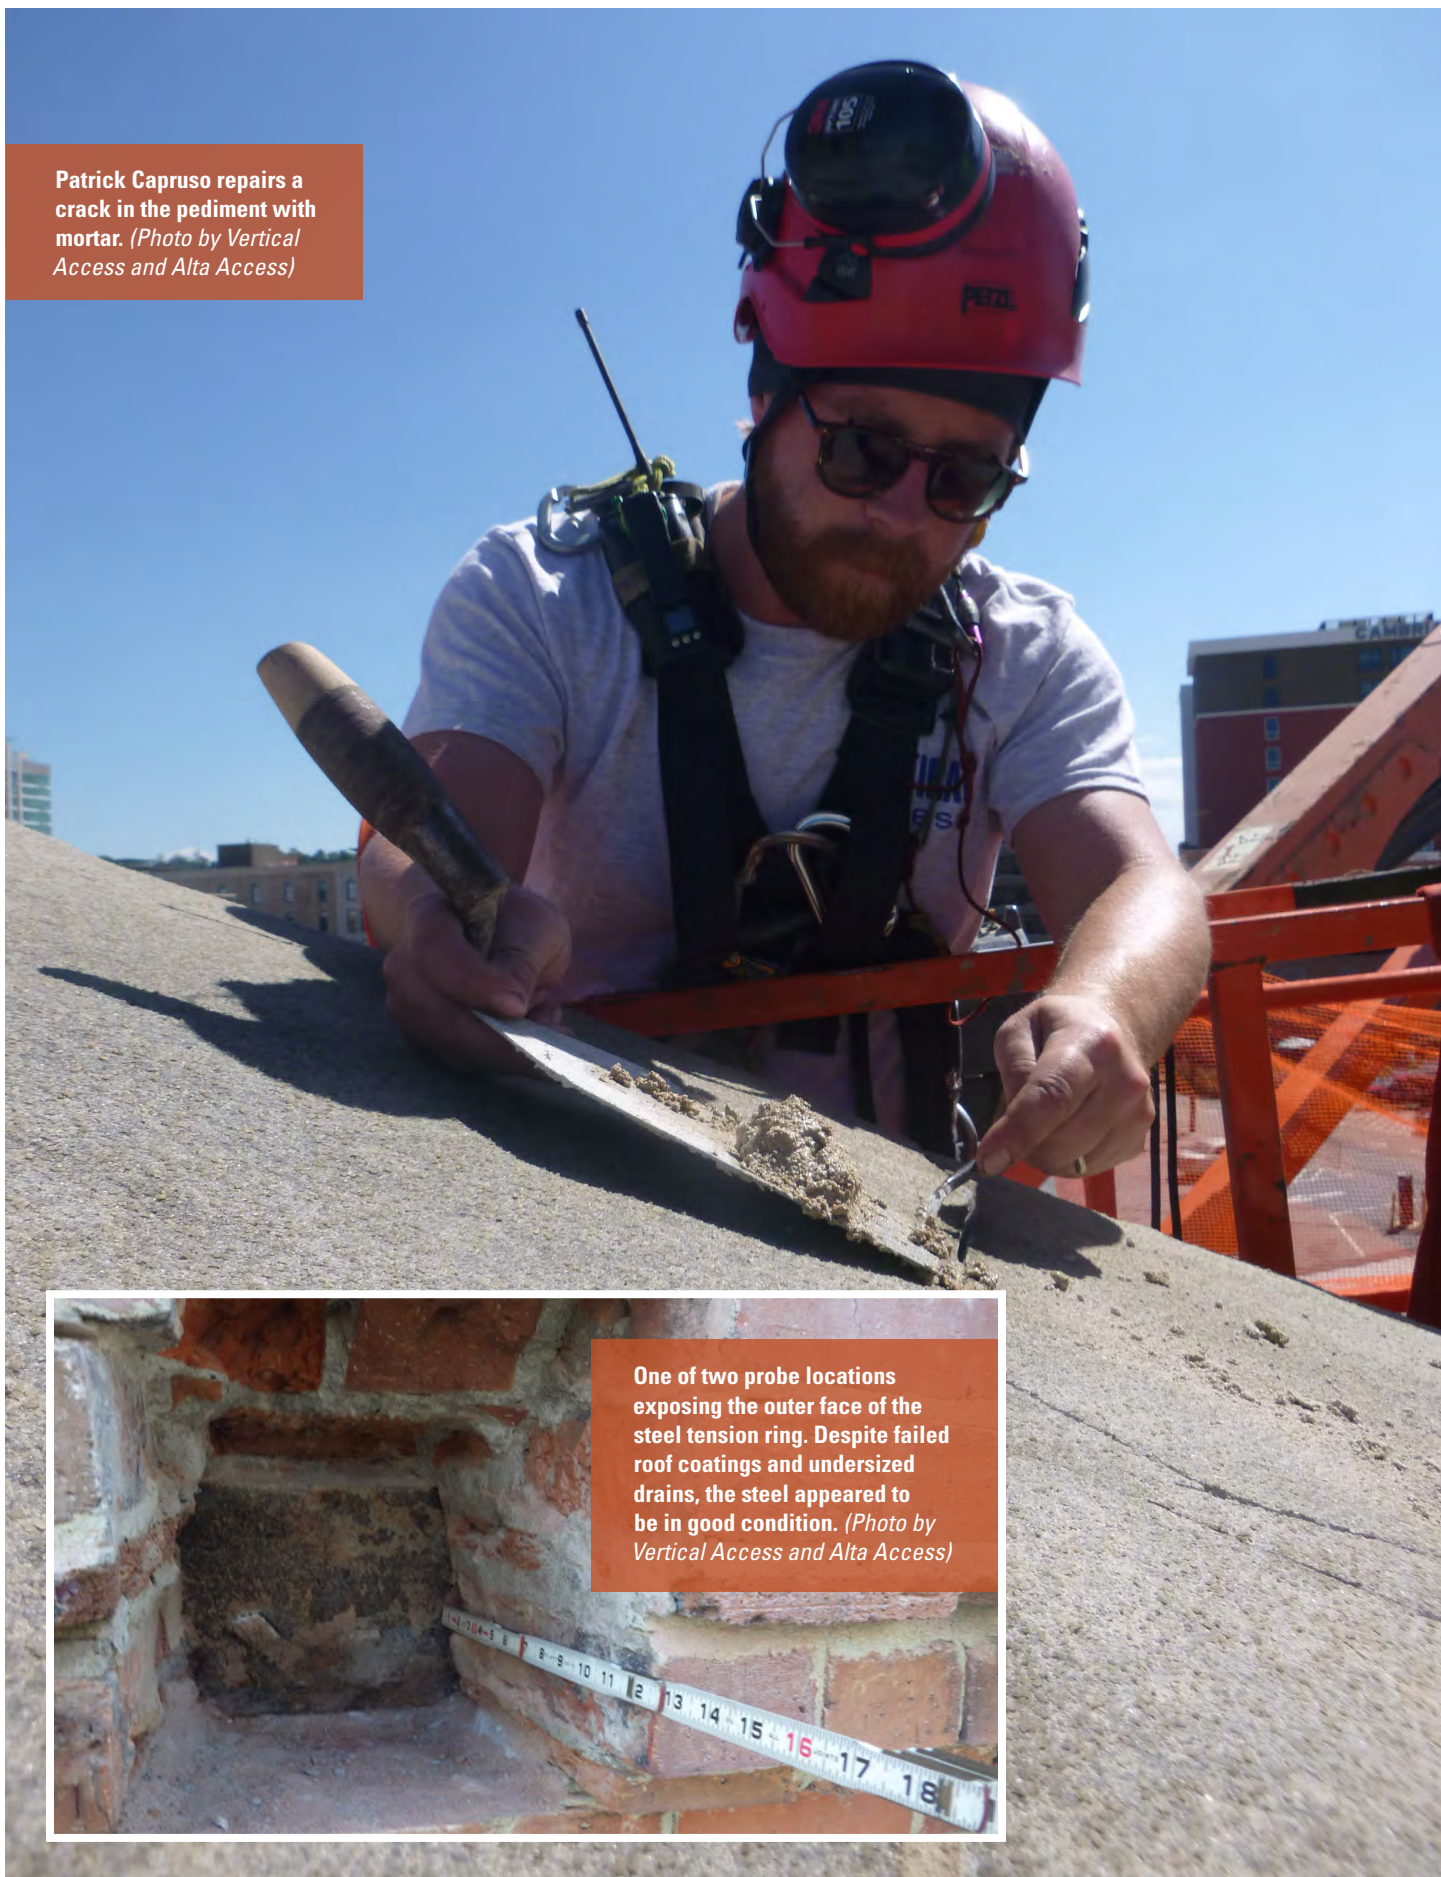
**Patrick Capruso repairs a crack in the pediment with mortar. (Photo by Vertical Access and Alta Access)**

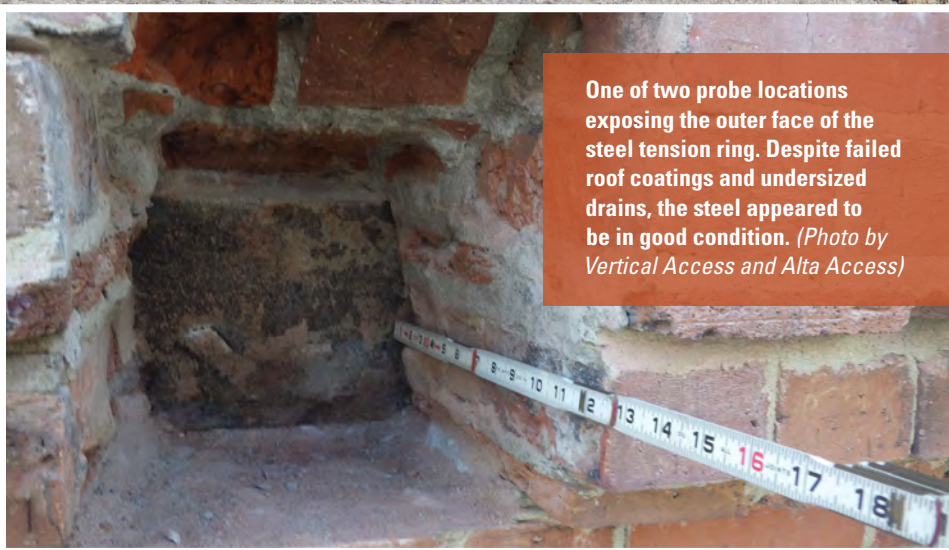
**One of two probe locations exposing the outer face of the steel tension ring. Despite failed roof coatings and undersized drains, the steel appeared to be in good condition. (Photo by Vertical Access and Alta Access)**
