**V**ertical Access owns and operates a fiber-optic diagnostic tool called the "SeeSnake®", along with a rigid fiber-optic borescope and metal detector, for the investigation of internal leaders/drain pipes, duct work, cavity walls, crawl spaces, and other locations where human access is not possible. This rugged device consists of a miniature video camera with wide angle lens and built-in light source attached to 200 feet of heavy duty fiber-optic cable.

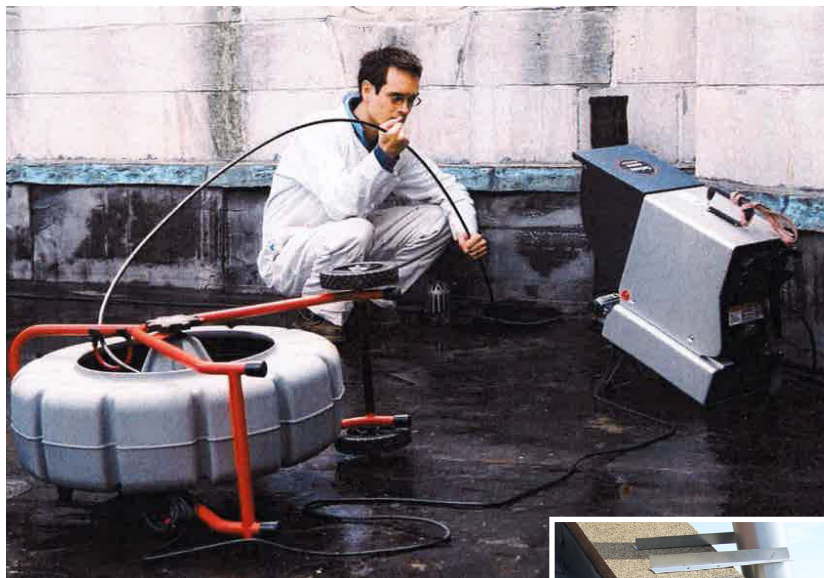
*Vertical cracks in an internal cast iron roof leader were identified using the SeeSnake®*

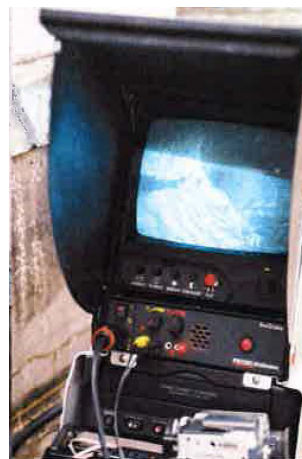
*Fiber-optic investigation of a drain pipe embedded within a masonry wall at St. Thomas Church in New York City.*

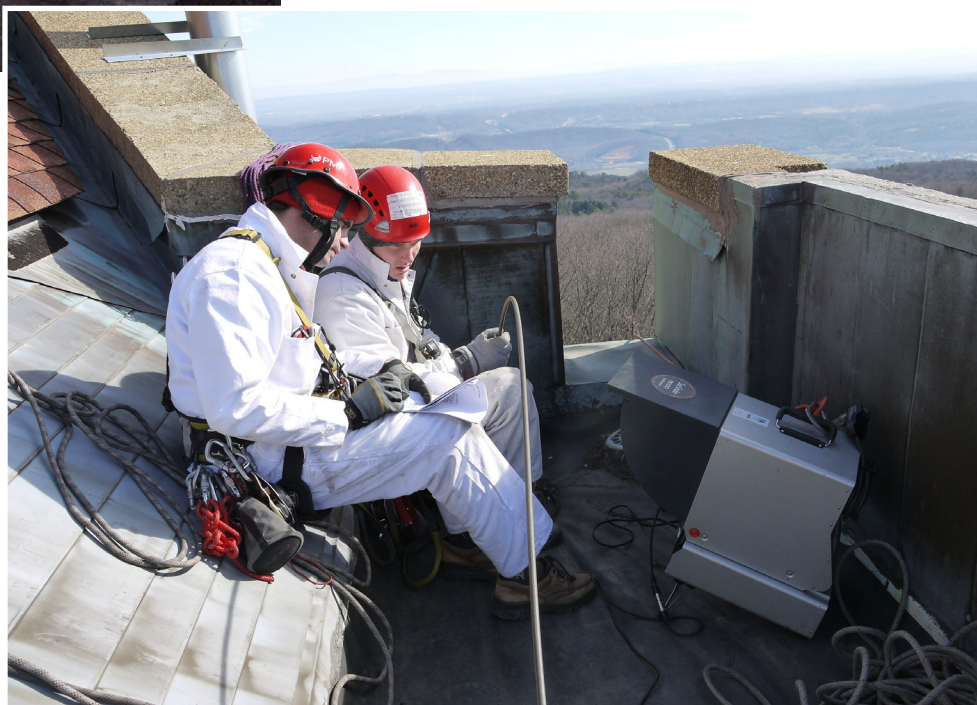
*A portable monitor allows the investigation to be viewed live while a digital video disk recored the video feed and narration made on site.*

The SeeSnake® has a portable monitor and VCR that is utilized on site for viewing and recording the video feed and operator's narration. The SeeSnake® can be used to investigate pipes 2 to 8 inches in diameter and can navigate horizontal and vertical surfaces as well as difficult 90° bends, diagonal runs, and connections.
