Fiber-optic investigation of a drain pipe embedded within a masonry wall at St. Thomas Church in New York City.

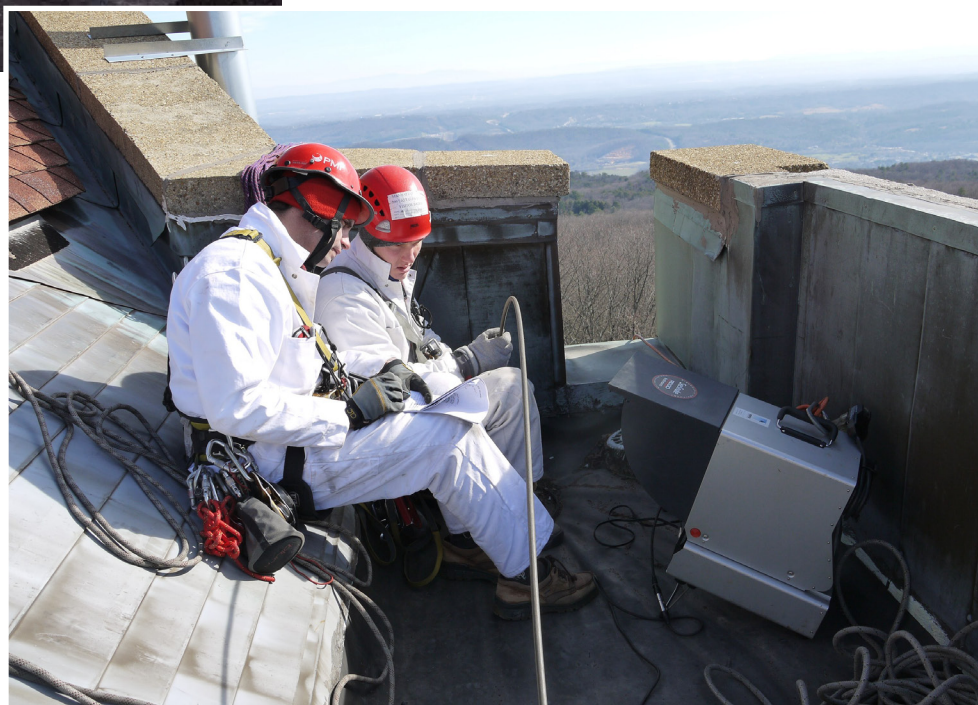
A portable monitor allows the investigation to be viewed live while a digital video disk recored the video feed and narration made on site.

The SeeSnake® has a portable monitor and VCR that is utilized on site for viewing and recording the video feed and operator's narration. The SeeSnake® can be used to investigate pipes 2 to 8 inches in diameter and can navigate horizontal and vertical surfaces as well as difficult 90° bends, diagonal runs, and connections.
