Adding Value to Building Maintenance & Operations

The Architect of the Capitol (AOC) was planning a major capital repair project to rehabilitate the dome of the United States Capitol. The rehabilitation project was scheduled for several years in the future, but the AOC was aware of conditions at the cast iron ornament of the dome that could potentially affect public safety.

The Peter W. Rodino, Jr. Federal Building in Newark, NJ is a 16-story concrete frame building with pre-cast concrete panels. Cracks ranging from hairline width to larger separations resulting in spalls were observed in the pre-cast panels.

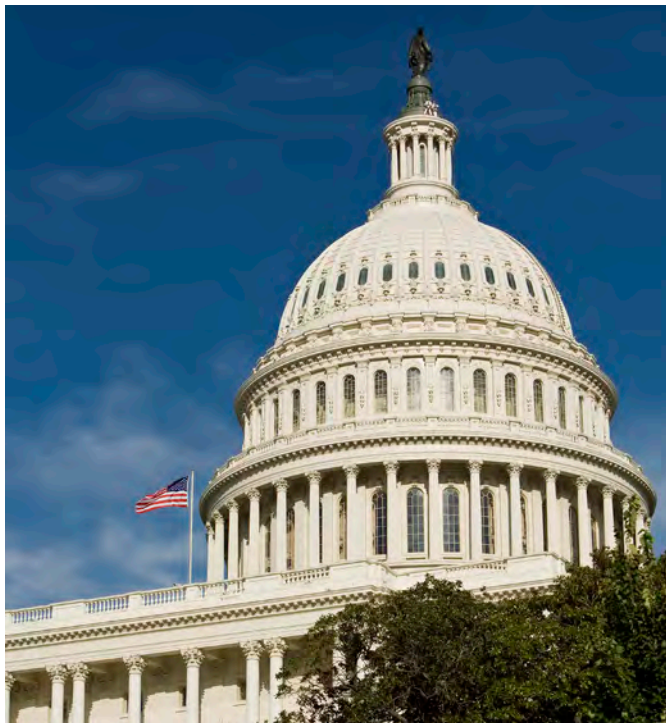
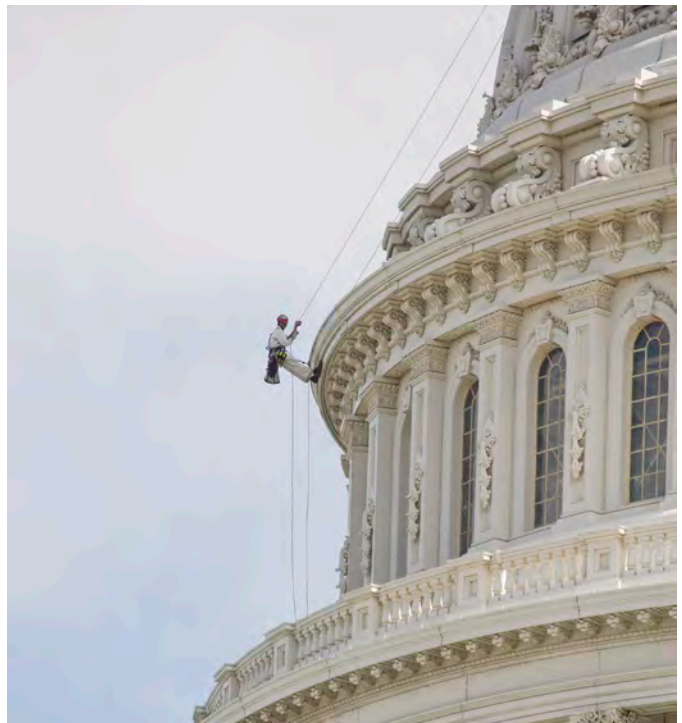
An initial inspection of cast iron ornament on the dome, documenting conditions of deterioration as well as

installing temporary waterproofing measures was performed. Two years later, a comprehensive inspection of the entire exterior of the dome was done using industrial rope access, updating the initial survey where conditions had continued to deteriorate and providing graphic, location and quantity data, which was used to create construction documents for the dome rehabilitation project.

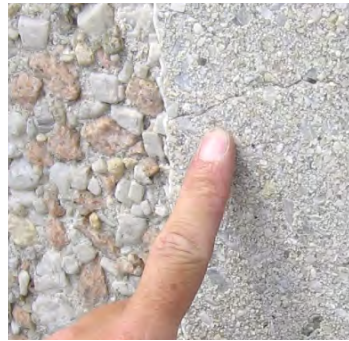
Some of the cracks present in the pre-cast concrete panels were likely present soon after the building was constructed in 1967, and others have developed due to ongoing corrosion of reinforcing in the panels. One of the challenges for maintaining the exterior façade of the Rodino Building was to determine the changes in the cracks over time.

Iterative inspections of the exterior envelope were performed to document the location and severity of cracks in the pre-cast concrete panels. As part of the inspections, public safety concerns were also addressed by removing loose concrete and installing netting to stabilize areas of cracked concrete.

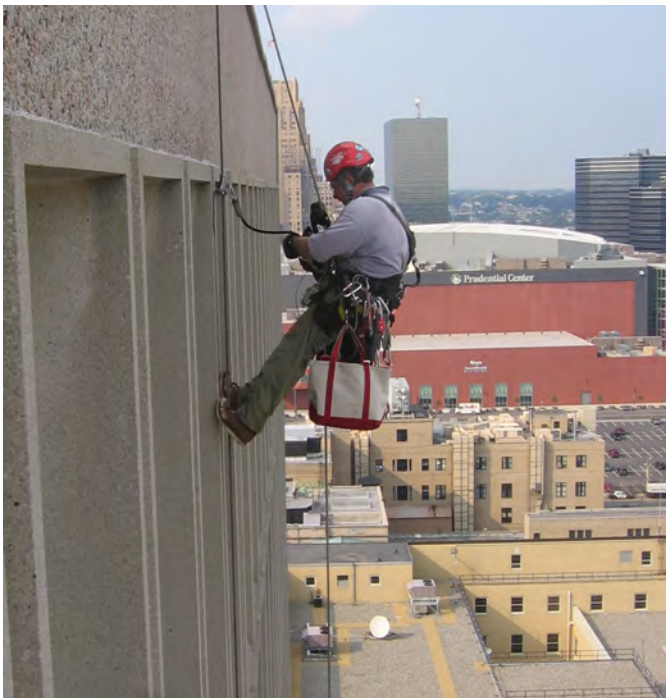
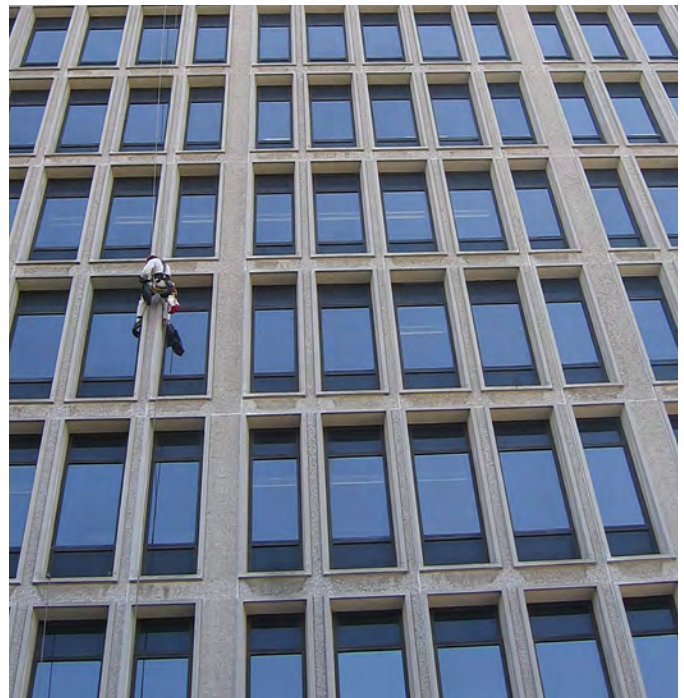
Information gathered during periodic inspections of the exterior façade of the Rodino Building has been used to track changes in the cracks over time.

Information gathered during periodic inspections of the exterior façade of the Rodino Building has been used to track changes in the cracks over time. With the data collected over several years, appropriate treatment of the exterior envelope could be developed. The temporary stabilization measures undertaken

have addressed public safety concerns at the building.
