Scope of work:

The Route 9W Bridge over Popolopen Creek near Fort Montgomery, NY is a steel truss bridge supported by concrete piers and abutments. The bridge was built in 1915 and widened in 1935. The east arch of the north pier, from which VA took core samples, dates to 1915 and the adjoining west arch of the north pier is part of the 1935 construction.

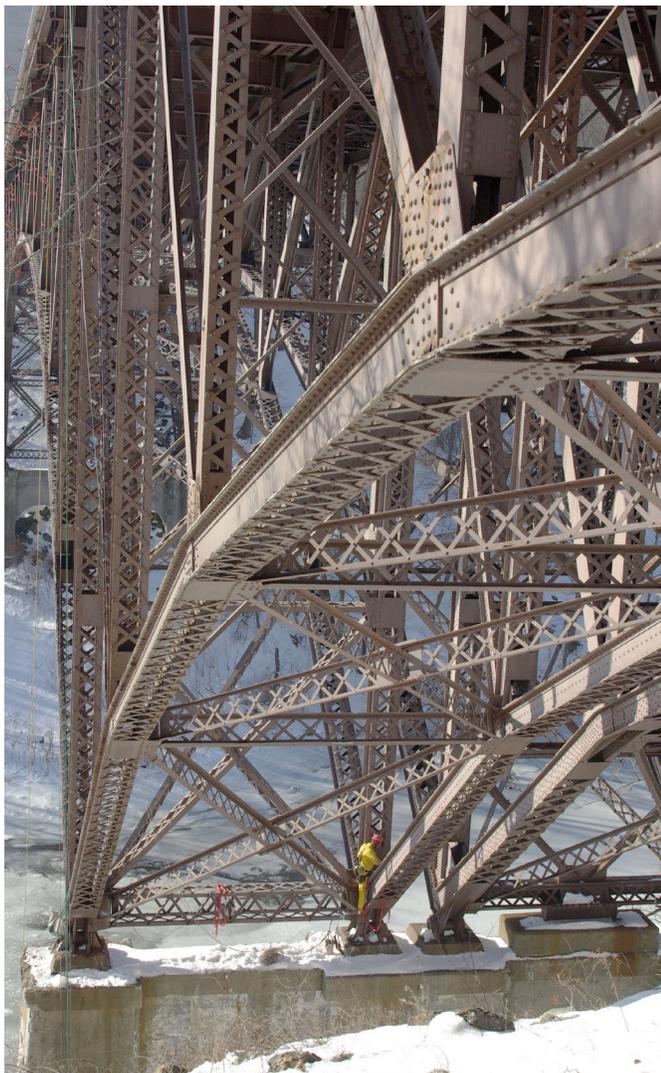
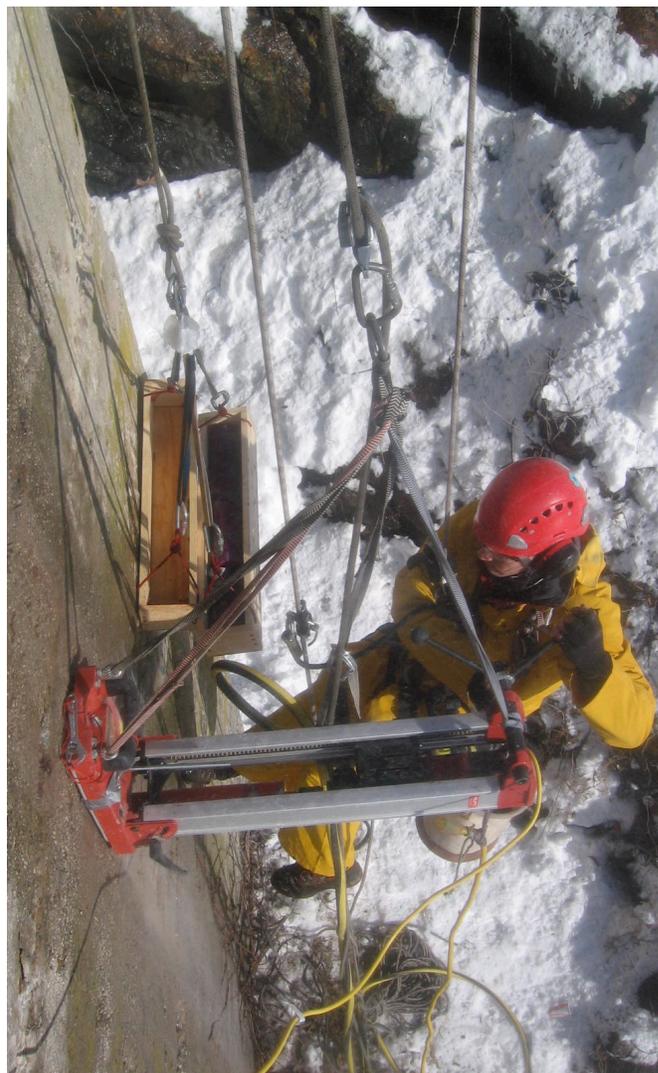
- Gained access to pier below bridge deck with no closure or disturbance to vehicular traffic.
- Took core samples up to two feet long from highly fractured concrete.

- Took core samples for testing of concrete physical properties by others.
- Performed in situ carbonation testing of concrete.
- Installed non-shrink grout at core sample locations following removal of cores.
