VERTICAL access

Fiber-optic investigation of a drain pipe embedded within a masonry wall at St. Thomas Church in New York City.

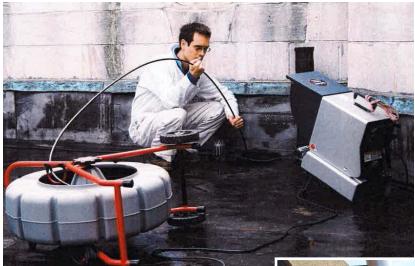
Vertical cracks in an internal cast iron roof leader were identified using the SeeSnake®

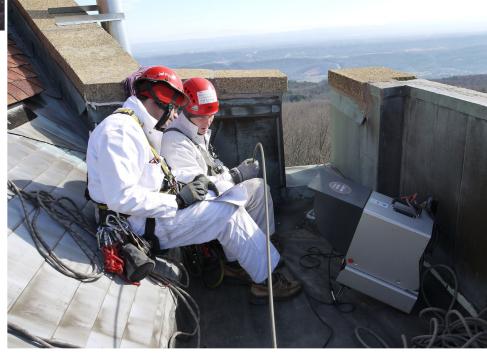
A portable monitor allows the investigation to be viewed live while a digital video disk recored the video feed and narration made on site.

The SeeSnake® has a portable monitor and VCR that is utilized on site for viewing and recording the video feed and operator's narration. The SeeSnake® can be used to investigate pipes 2 to 8 inches in diameter and can navigate horizontal and vertical surfaces as well as difficult 90° bends, diagonal runs, and connections.
