Condition Surveys of Inaccessible Areas of Concrete Dams

Evan Kopelson, Vertical Access LLC / Alta Access LLC
Michael Likavec, P.E., Puget Sound Energy

Presented at Dam Safety 2017
Annual Conference of the Association of State Dam Safety Officials
San Antonio, Texas, September 12, 2017

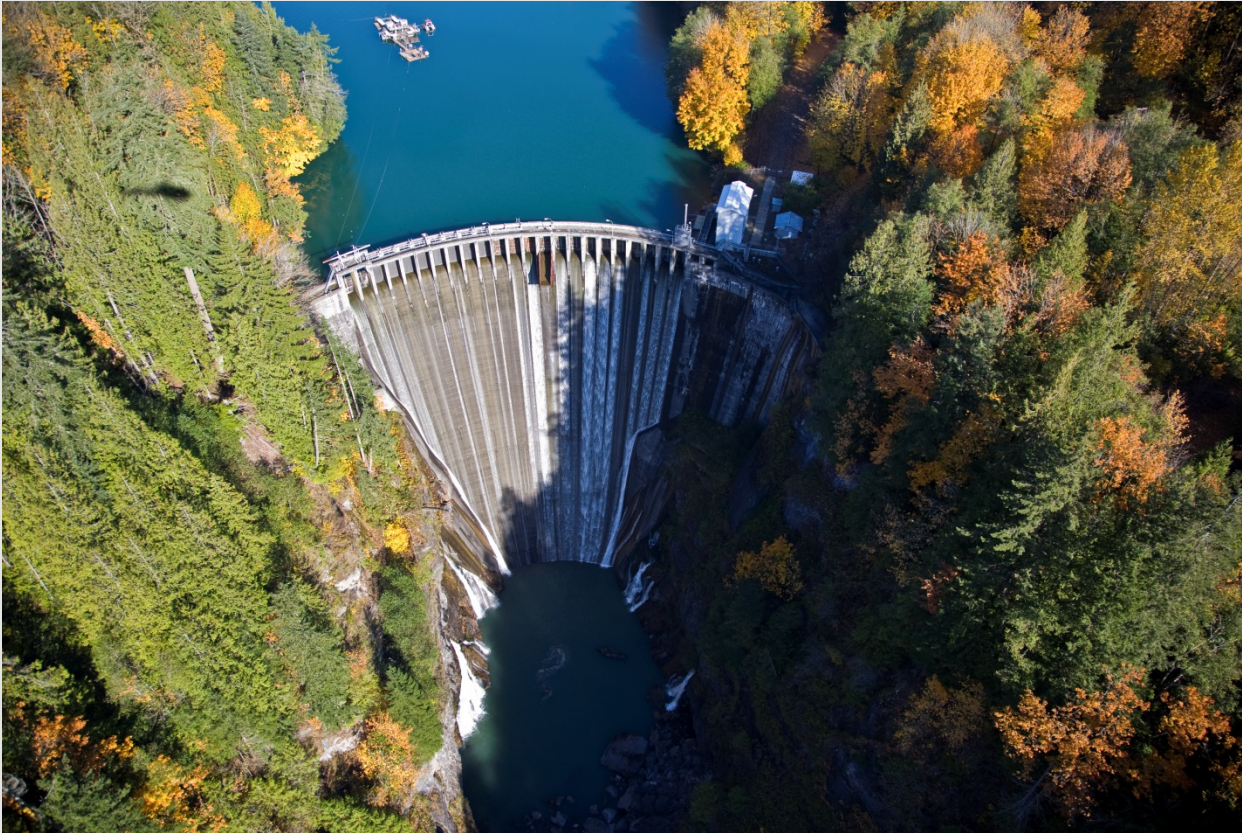
Lower Baker Dam: Overview

Concrete Gravity
Arch Dam in Skagit
County, WA

Completed 1925

285 feet tall, 550
feet across crest

2,278 acres at full
pool

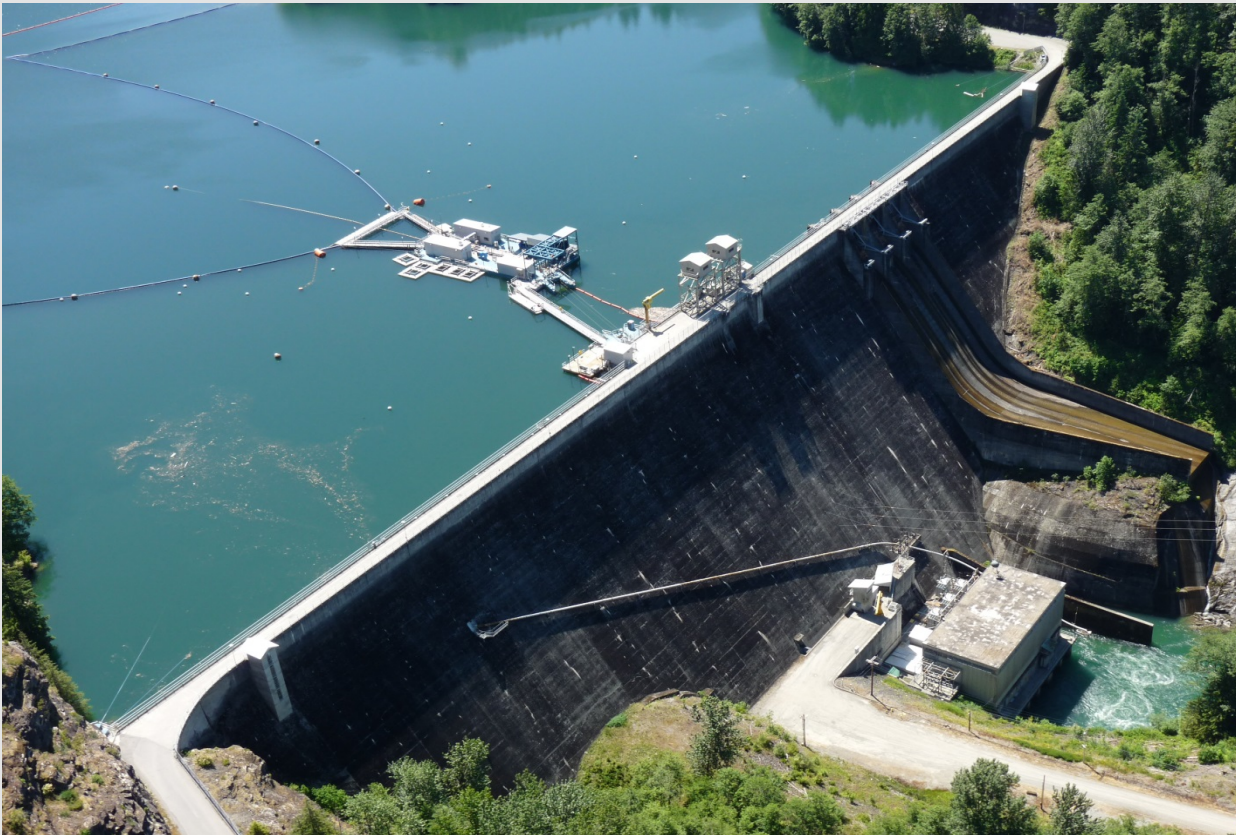
Upper Baker Dam: Overview

Concrete Gravity
Dam in Whatcom
County, WA

Completed 1959

312 feet tall, 1,235
feet across crest

4,980 acres at full
pool

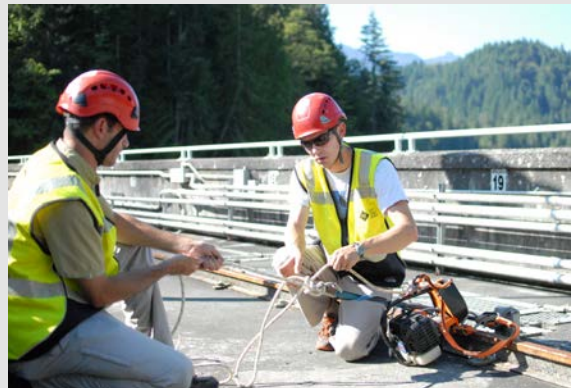
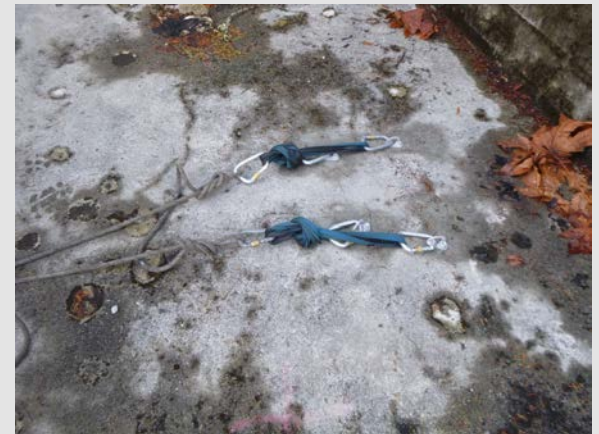
Industrial Rope Access

Existing anchors

Encirclement anchors

Removable anchors

Rig to haul

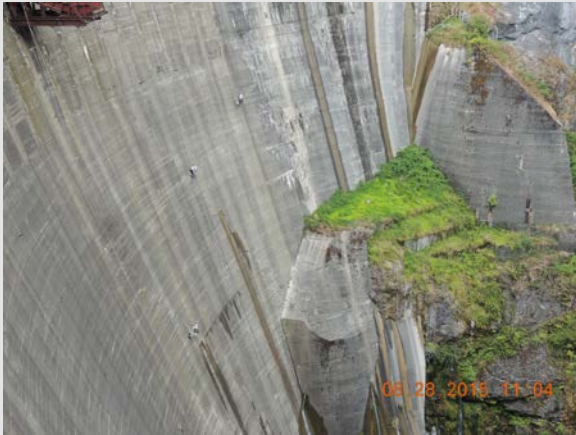
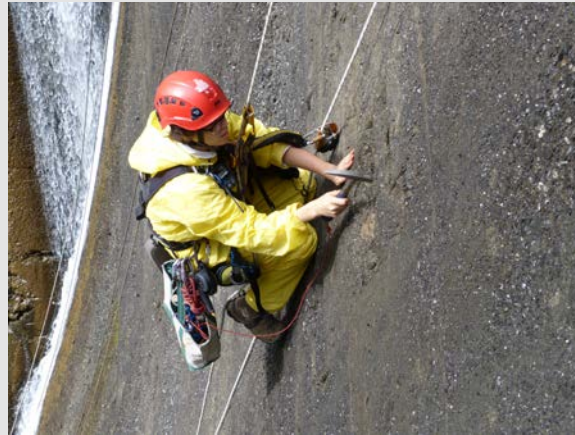
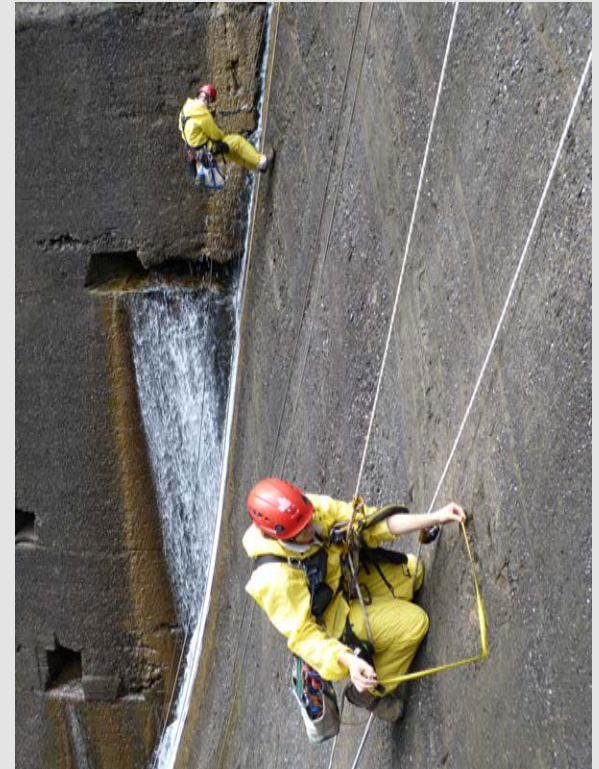
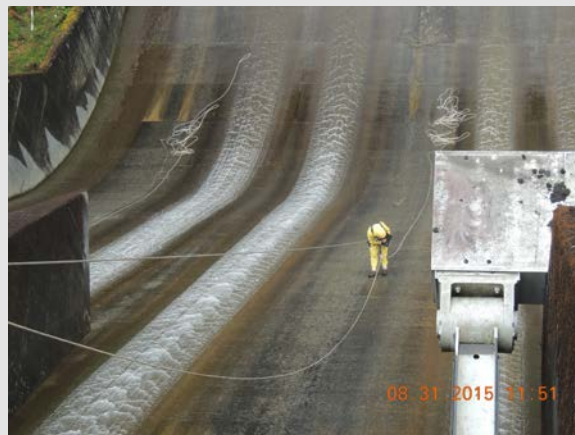
Inspection

Hands-on access
Hammer-sounding
Measurements
Documentation

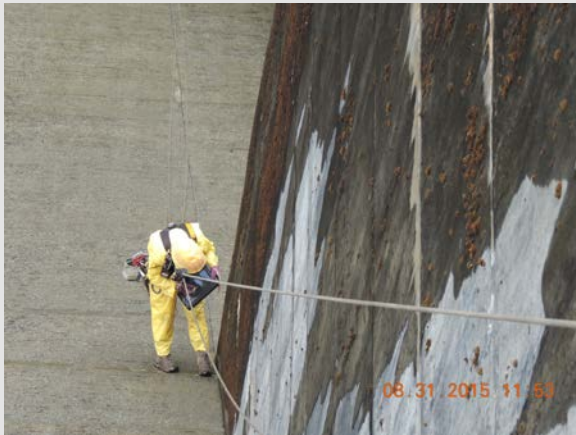
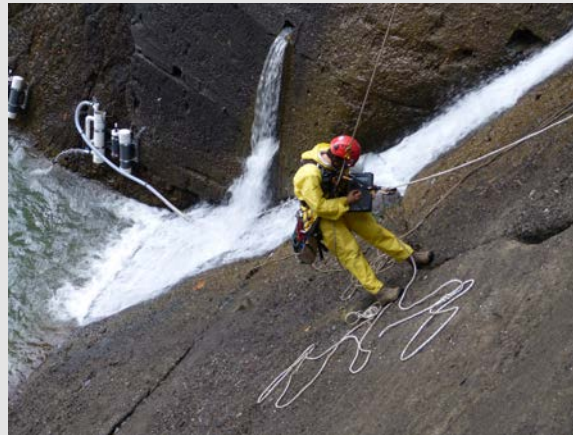
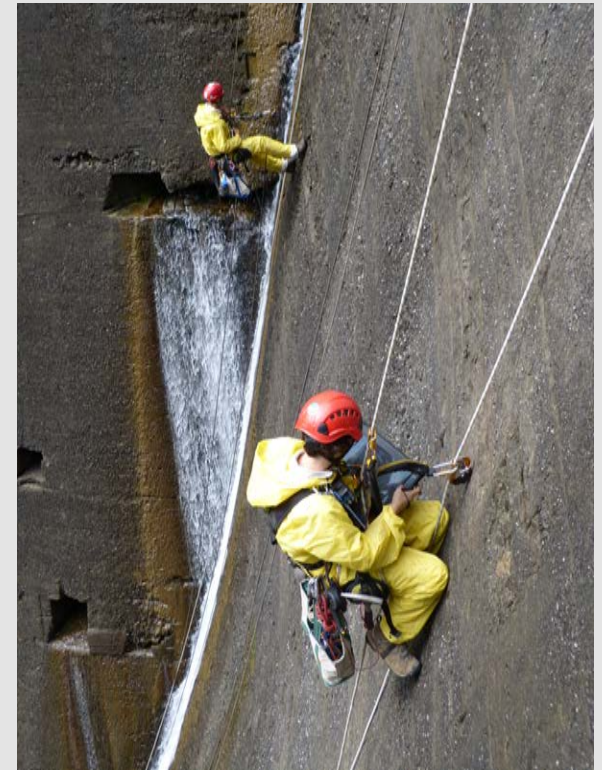
Documentation

Tablet PC Annotation System

Tablets running windows with
AutoCAD

Small digital cameras

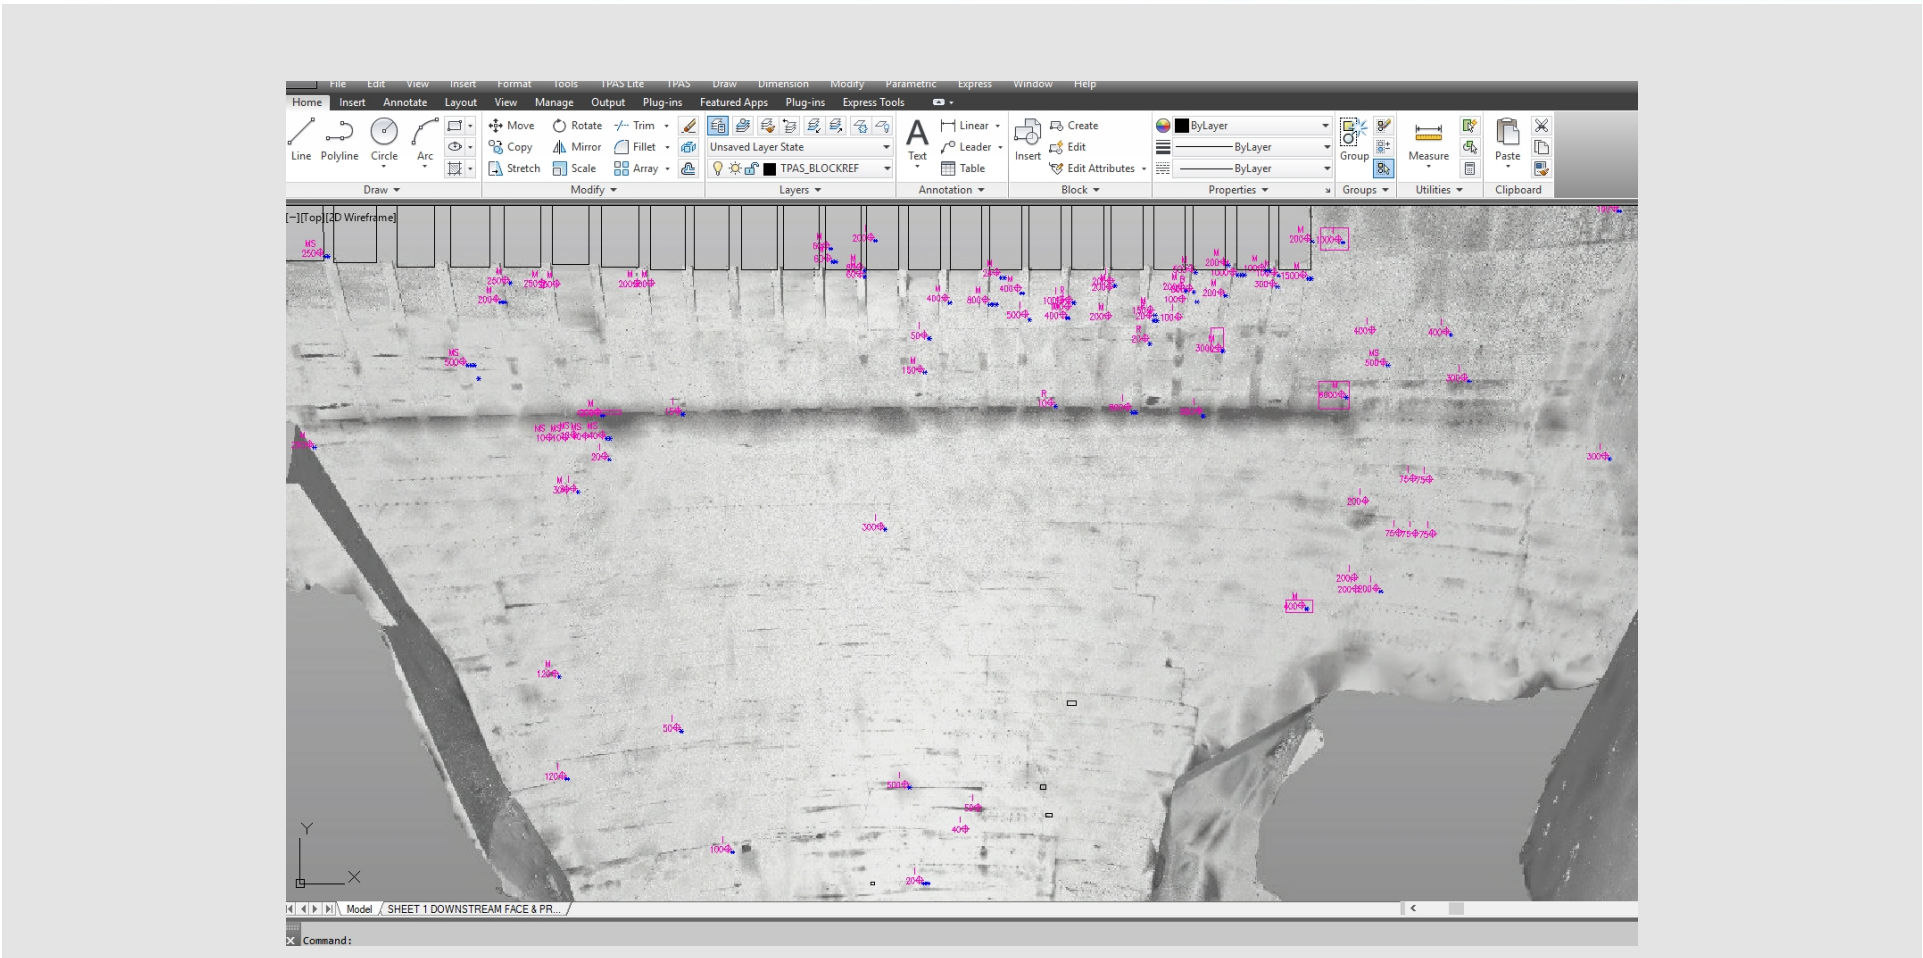
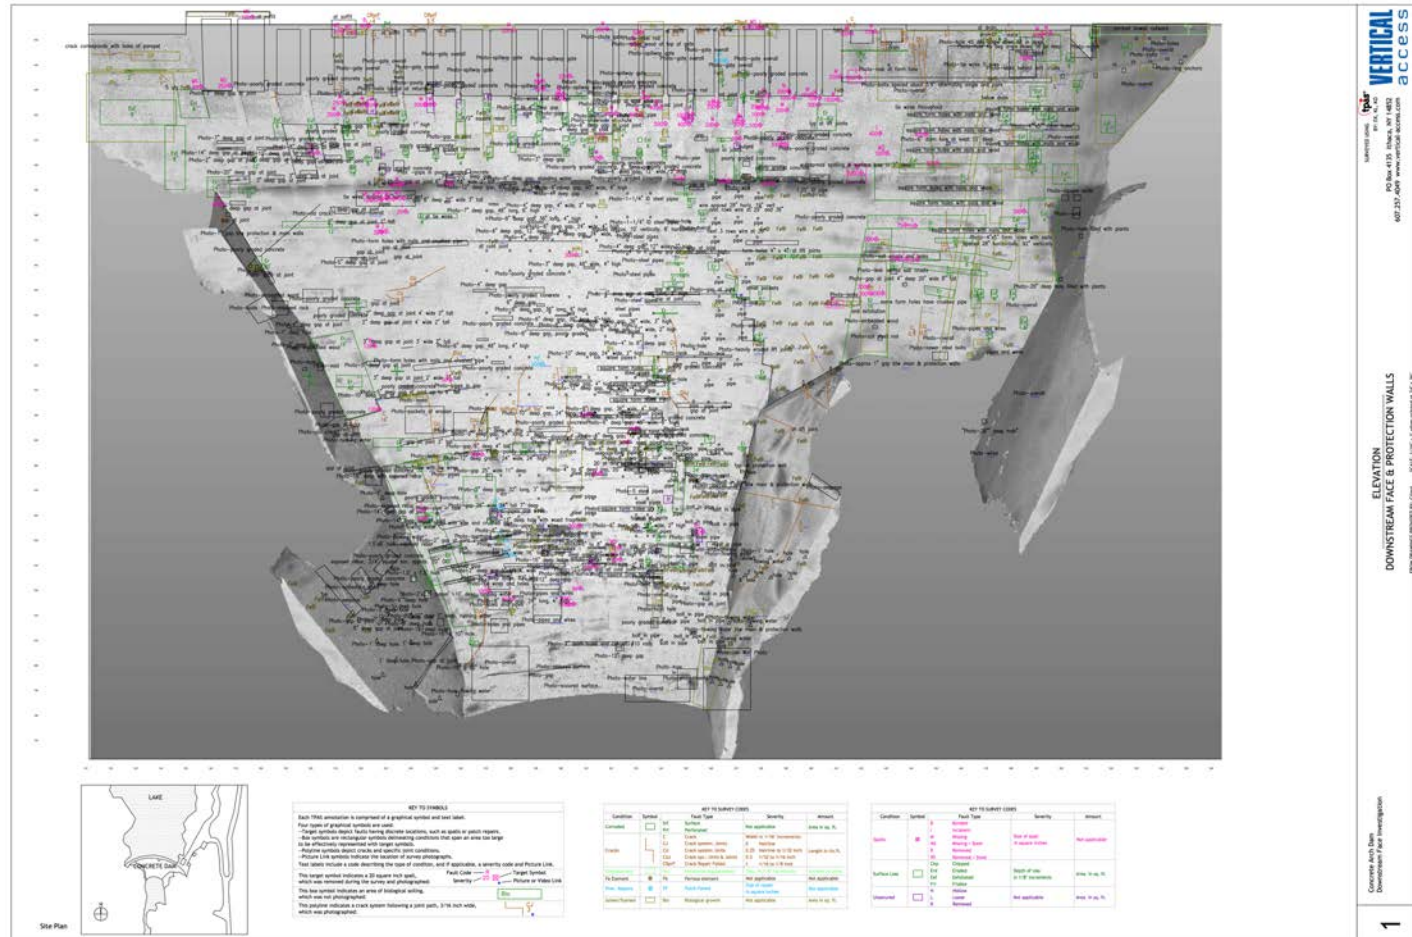
Documentation: TPAS

ELEVATION
DOWNSTREAM FACE & PROTECTION WALLS

Copyright 2010
Downstream Face Investigation
