CASE STUDY: JAMES M. HANLEY FEDERAL BUILDING Building Envelope Investigations

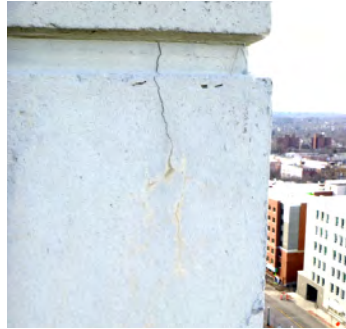
spalling and cracking in the concrete were recorded. The concrete materials were sounded with 16-ounce acrylic mallets and steel hammers during the investigation to help in the assessment of their condition. As part of the façade investigation, loose concrete was removed to address immediate public safety concerns.
