# Saving the Basilica

CREATIVE ACCESS SOLUTIONS FOR  
INSPECTION AND CONTRACTING  
WORK AT HEIGHT

BY KRISTEN OLSON AND  
KELLY STREETER, PE

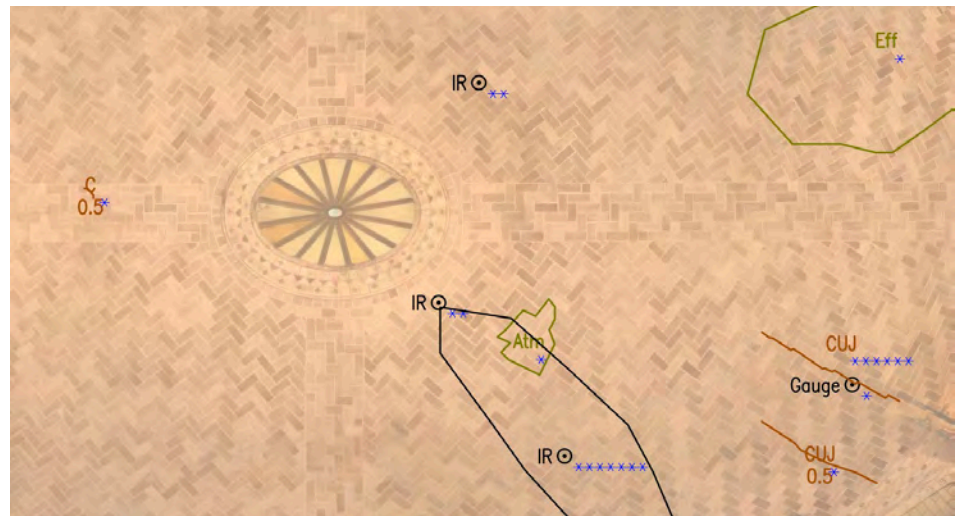
**Reflected ceiling plan showing conditions documented using TPAS. Annotations indicate the locations of cracked tile units ("C"), crack systems through units and joints ("CUJ"), efflorescence ("Eff"), atmospheric soiling ("Atm"), infrared imagery ("IR"), and a crack gauge. The blue asterisks are hyperlinks to photographs associated with each annotation.**

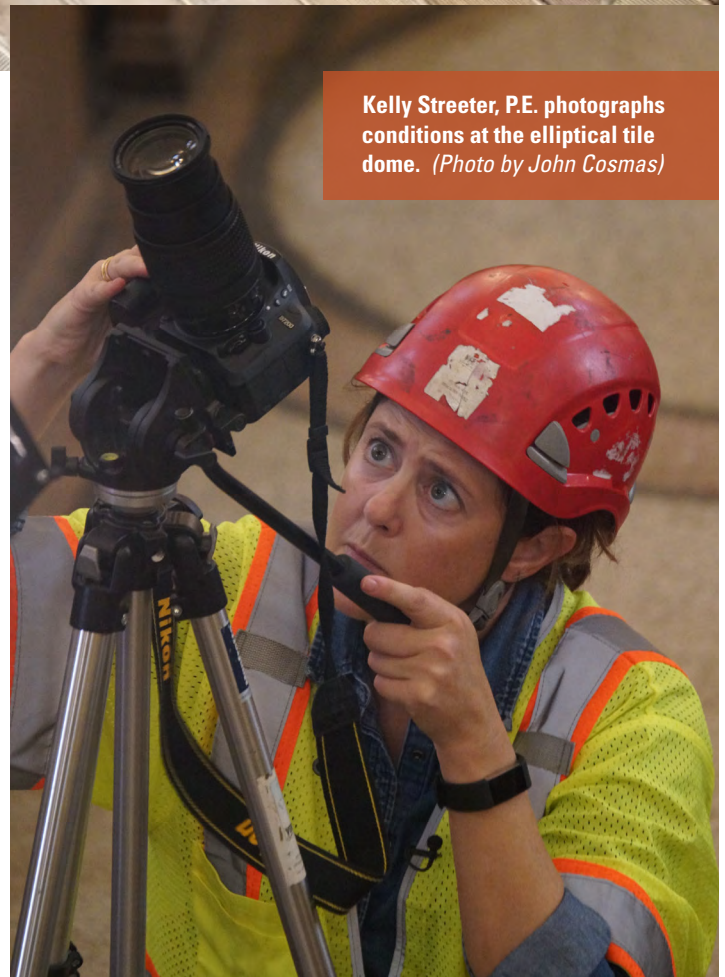
Kelly Streeter, P.E. photographs conditions at the elliptical tile dome. (Photo by John Cosmas)

**“Although the elliptical main dome appears to be in overall good condition, VA identified moisture within the tile masonry based on the infrared imagery.”**

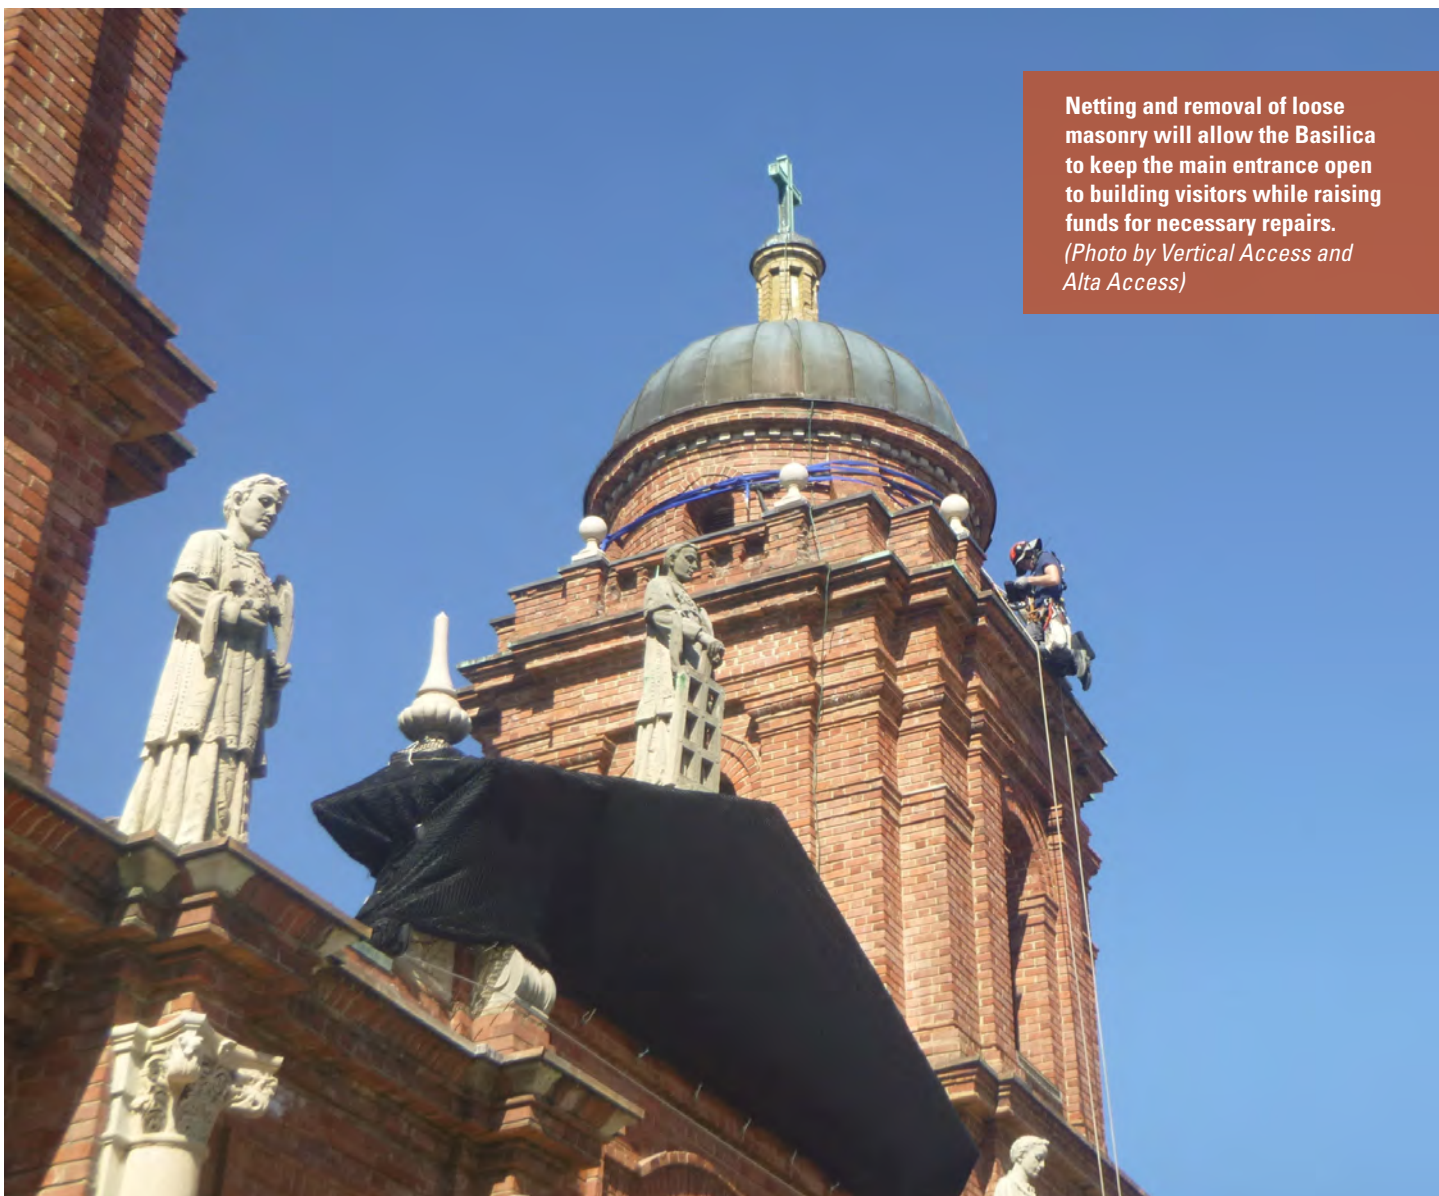
Netting and removal of loose masonry will allow the Basilica to keep the main entrance open to building visitors while raising funds for necessary repairs.

Alta technicians removed damaged portions of three terra cotta finials. Discrete areas of loose brick masonry were removed by hand at the towers and east façade, while larger areas of deteriorating and unstable masonry were mitigated by the installation of debris containment netting. Three netting samples were installed in easy-to-access locations representing a variety of exposures, while a fourth control sample was left with the building manager for future evaluation of the netting performance in different weathering conditions.
