As part of Vertical Access' investigation of buildings and structures, we typically prepare a detailed and comprehensive Condition Survey Report. VA documents existing conditions using a combination of digital still color photography keyed to annotated drawings. To record existing conditions, Vertical Access has developed the Tablet PC Annotation System (TPAS®) that allows on-site annotation directly in AutoCAD. TPAS allows Vertical Access to input both graphical and numerical data directly into AutoCAD, on site, using tablet computers and digital cameras. We submit to the project client the Condition Survey Report in two formats: 1) a bound report with a written narrative, color photographs and annotated drawings and 2) a DVD or flash drive with digital files of all of the deliverables.

Louisiana State Capitol Vertical Access LLC
 Exterior Investigation Job Number 16-1794
 Baton Rouge, LA 35 of 36 July 1, 2016

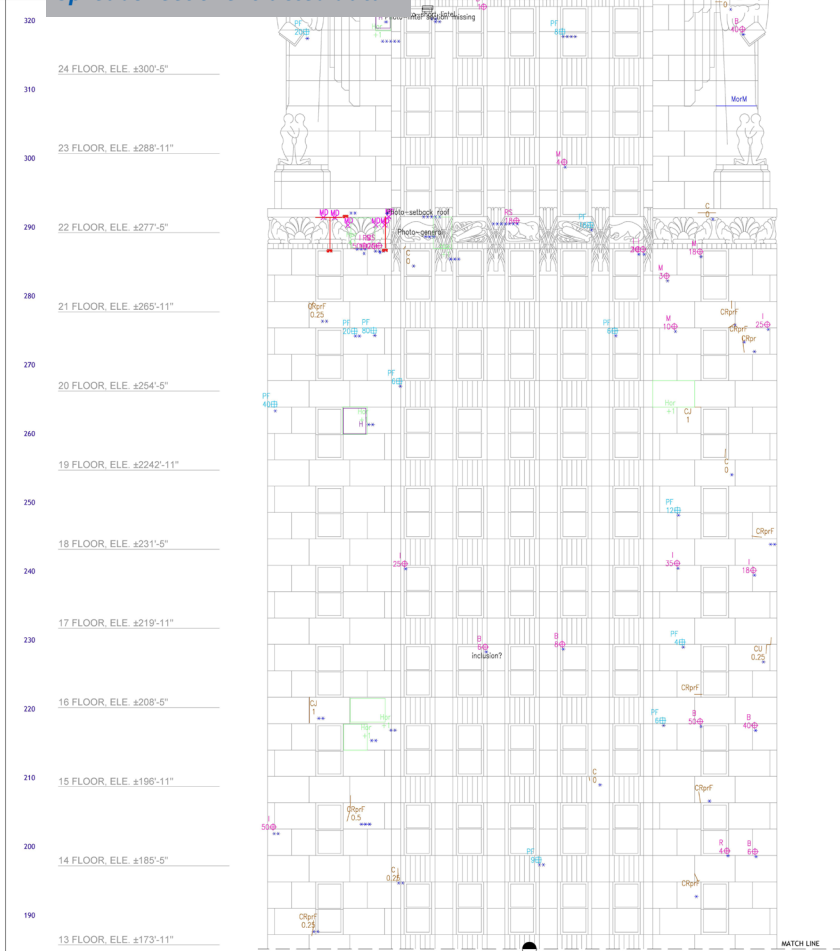
Spreadsheet of extracted data

Spreadsheet of Extracted Data: VA includes in the bound report a spreadsheet containing the numerical survey data such as crack length and area of soiling that are recorded in the annotated AutoCAD drawings. The spreadsheet is also submitted digitally as an .XLS file that can be further formatted according to the various needs of the project.

Extracted Survey Conditions								
Block Name	Condition	X	Y	Code	Severity	Amount	Priority	Photo
Stone_SurfLoss	Chipped	1802	385	Chp	1	2.8	P2	Yes
Stone_SurfLoss	Chipped	196	22	Chp	1	0.8	P2	Yes
Stone_SurfLoss	Chipped	1804	351	Chp	2	2.8	P2	Yes
Stone_SurfLoss	Chipped	1283	308	Chp	0.5	0.1	P2	No
Stone_SurfLoss	Chipped	1231	85	Chp	1	0.5	P2	Yes
Stone_SurfLoss	Chipped	718	148	Chp	2	0.2	P2	Yes
Stone_SurfLoss	Chipped	1276	351	Chp	2	0.0	P2	No
Stone_SurfLoss	Chipped	1272	401	Chp	1	0.0	P2	Yes
Stone_SurfLoss	Chipped	1262	91	Chp	2	4.8	P2	Yes
Stone_SurfLoss	Chipped	1263	275	Chp	1	0.5	P2	Yes
Stone_SurfLoss	Chipped	1258	73	Chp	3	0.4	P2	Yes
Stone_SurfLoss	Chipped	215	179	Chp	1	0.2	P2	Yes
Stone_SurfLoss	Chipped	1271	249	Chp	1	1.0	P2	Yes
Stone_SurfLoss	Chipped	1275	348	Chp	2.5	0.3	P2	Yes
Stone_SurfLoss	Chipped	1277	132	Chp	1	0.6	P2	Yes
Stone_SurfLoss	Chipped	1284	161	Chp	0.5	0.2	P2	Yes
Stone_SurfLoss	Chipped	1288	126	Chp	0.5	23.4	P2	Yes
